Backup Box Troubleshooting Guide

Huawei Technologies Co. Ltd.

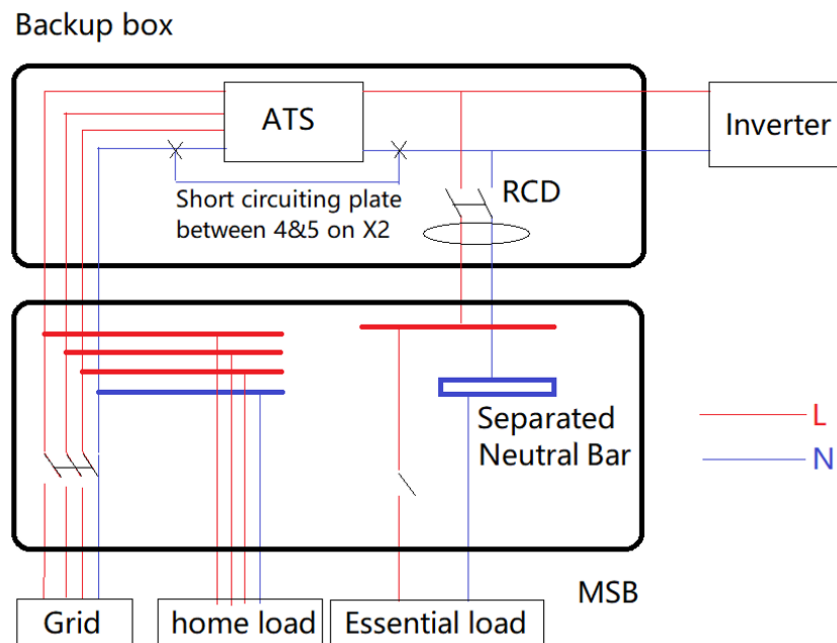
To rule out wiring issue

- Essential loads should be connected to a separated neutral bar
- Separated neutral bar, UNLIKE other home loads, must NOT be connected to Neutral link in MSB
